WSP File No: 171-02203-00

Project: Vedder Mountain Landslide near 43980 Vedder Mountain Road, Chilliwack, BC

Subject: Geotechnical Assessment Report

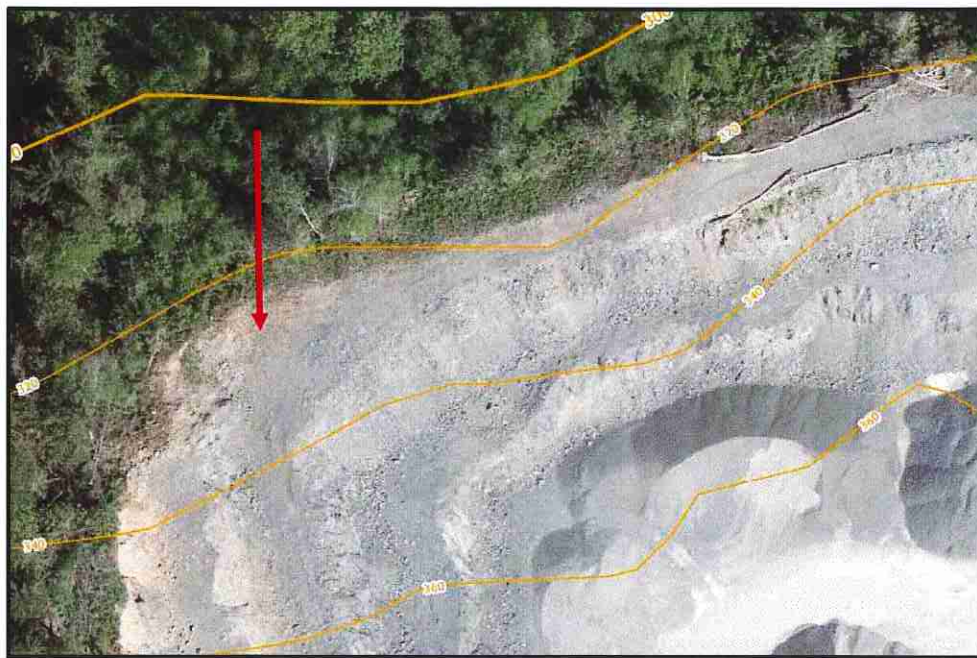
Imagery from the City online mapping shows that a turn-around area was constructed in the vicinity of the landslide initiation zone between 2012 and 2016. This imagery suggests that quarry material may have been pushed onto or over the top of slope to construct the turn-around area. The 2012 and 2016 imagery is shown on Figures 3 and 4, respectively.

Figure 3: The 2012 imagery with the red arrow showing the approximate location of the landslide headscarp.

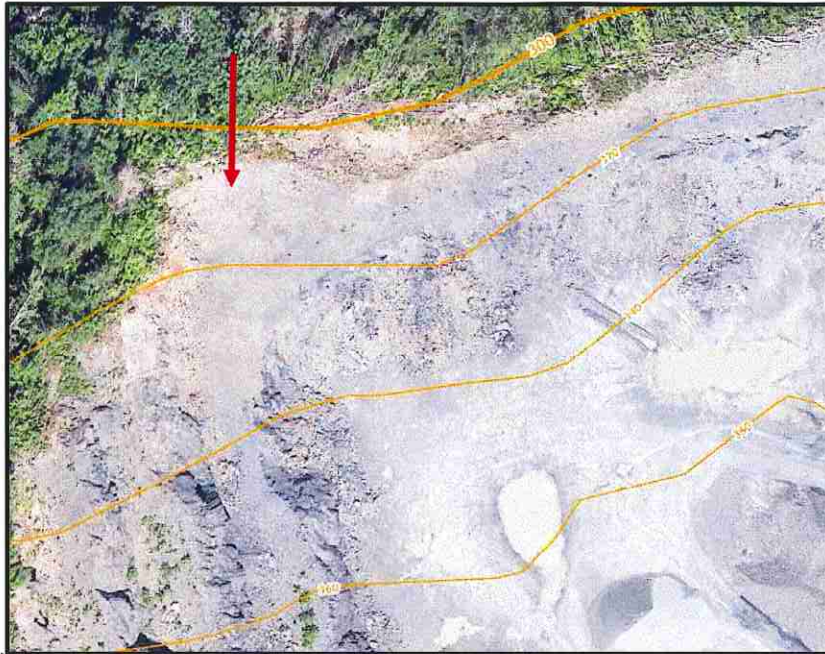
Figure 4: The 2016 imagery showing approximate location of the initiation zone marked with a red arrow. The new turn around area extends to the north within the initiation zone.

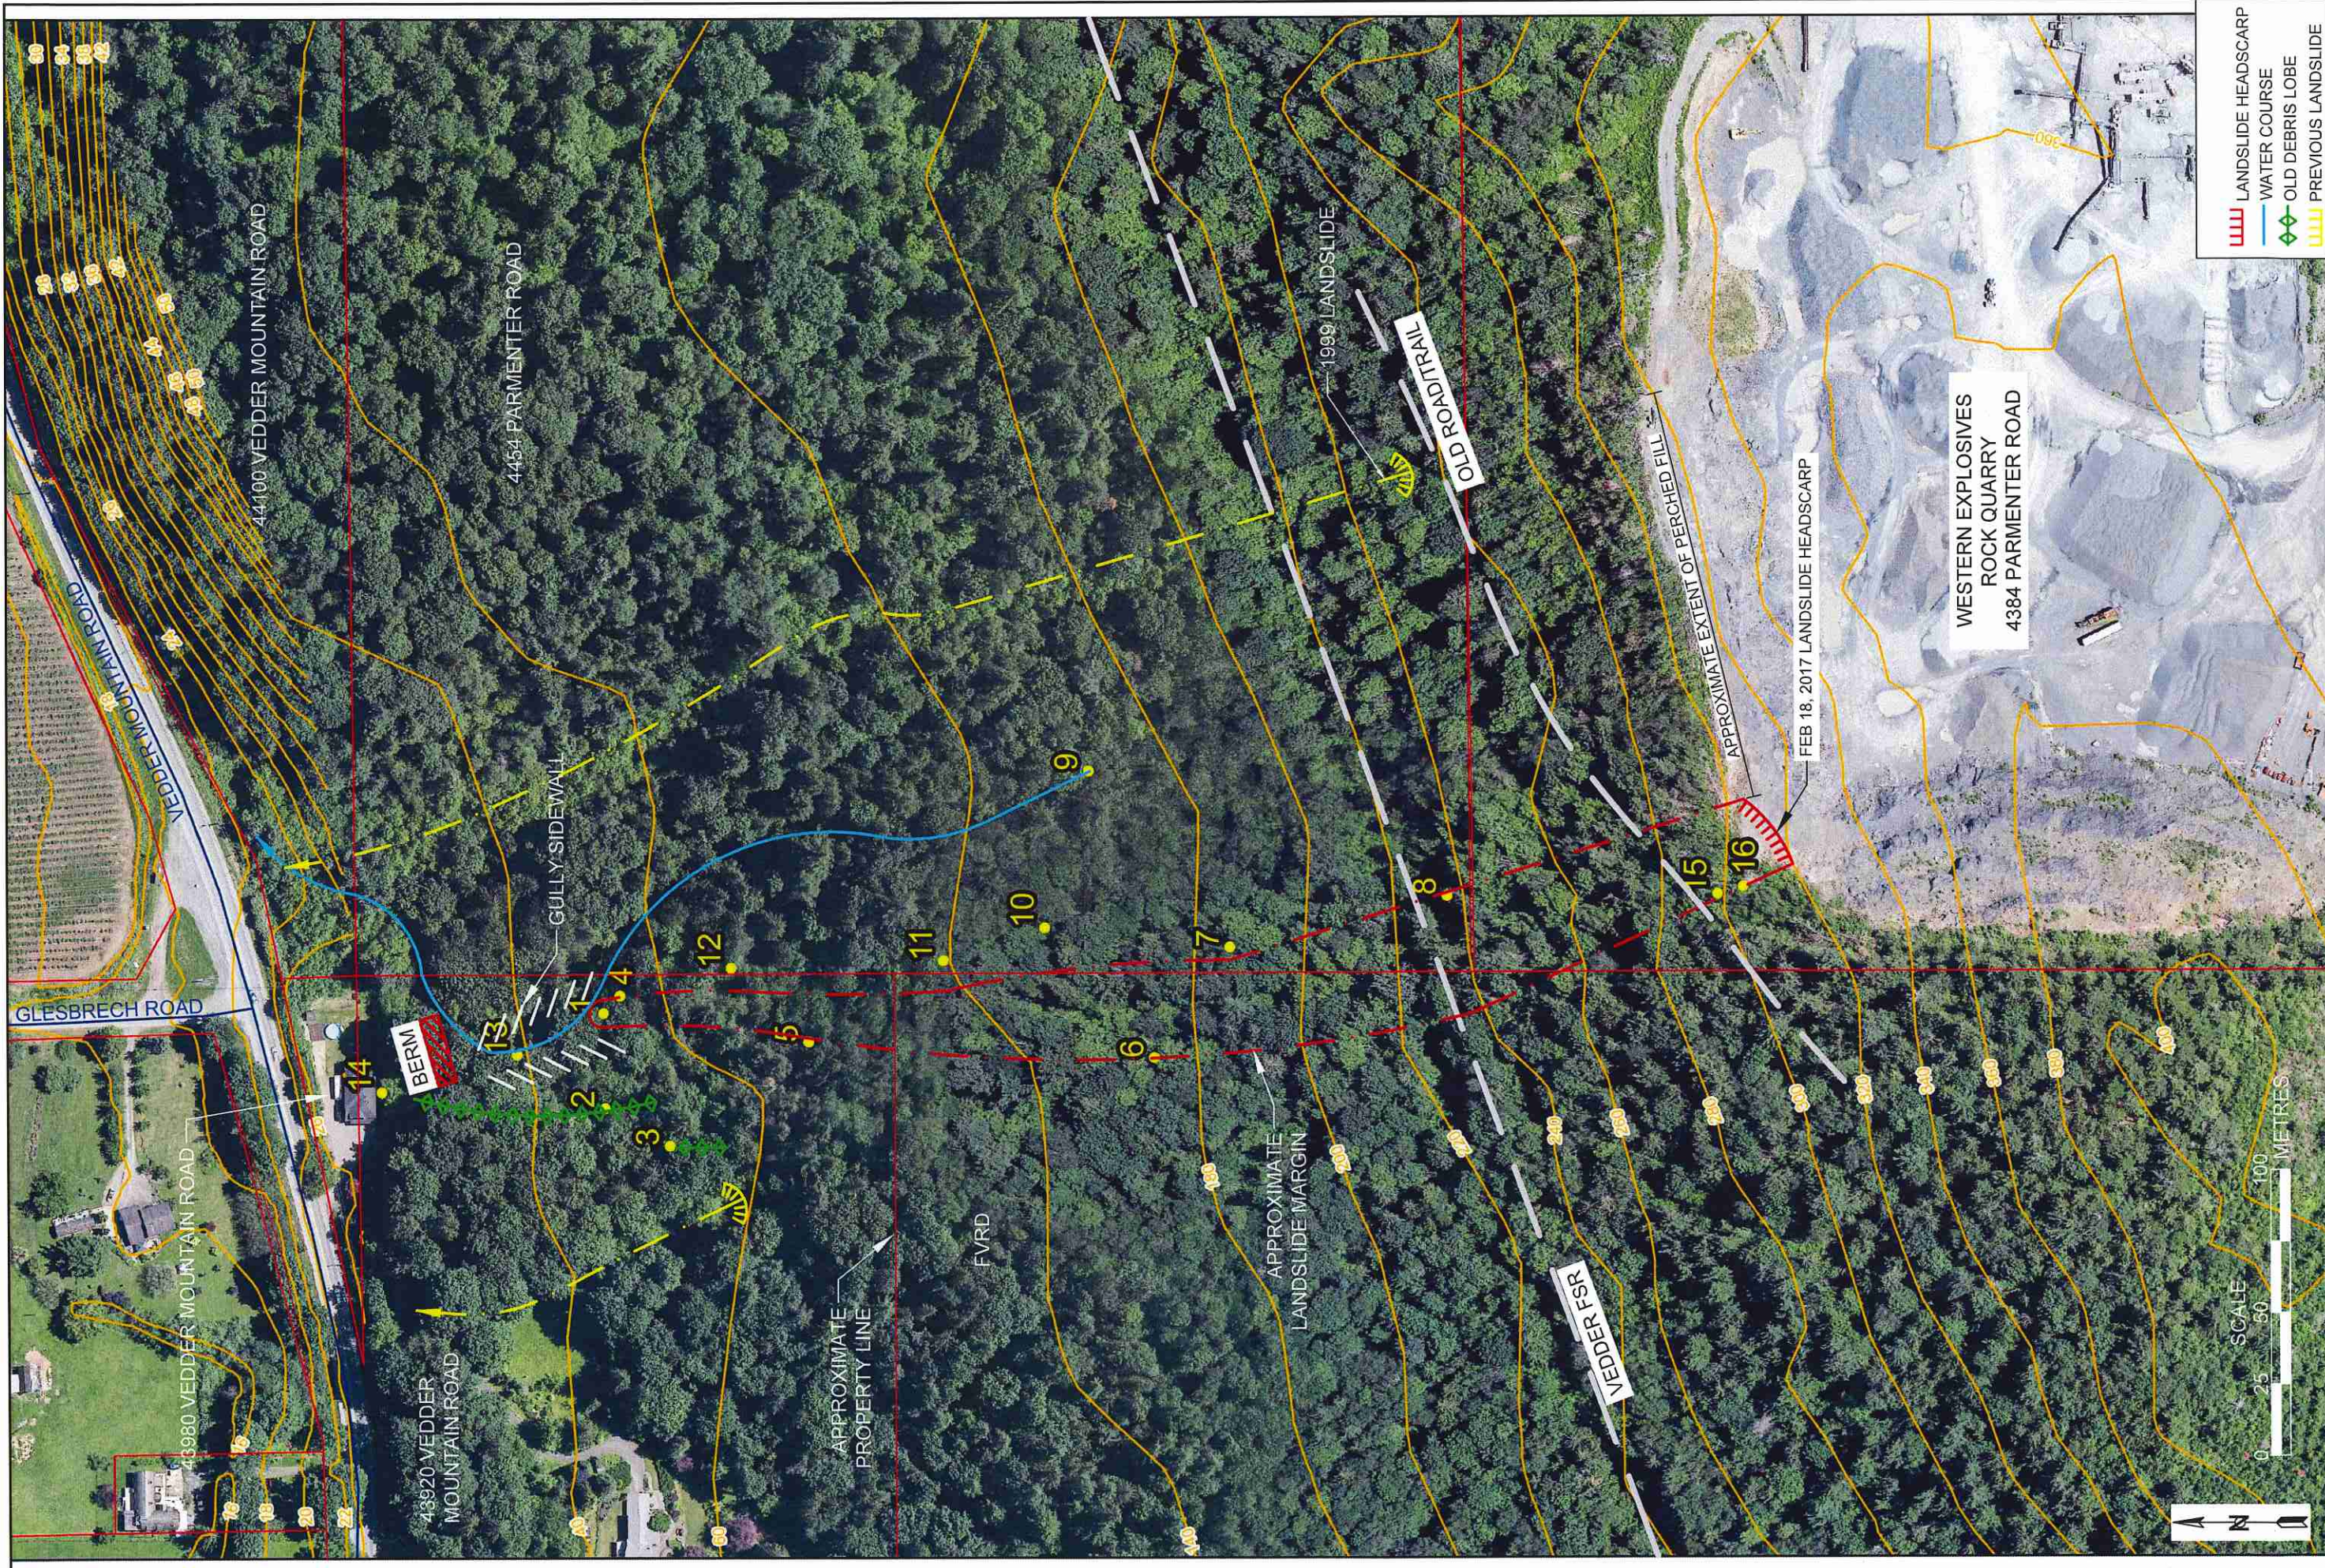
During our review of the northwestern portion of the quarry, WSP observed an approximate 100 m long segment of perched fill along the top of slope, shown on Figure 2. The perched fill is comprised of loose angular cobbles and boulders, trees, stumps and overburden material comprised of various amounts of sand and silt (see Photographs 6 and 7). The gradients of the fill slopes ranged between about 30 and 45 degrees for about 5 to 10 m. The native slope gradients below the perched fill slopes ranged between about 35 and 45 degrees for at least 30 m. Buried trees and stumps were observed supporting the fill slopes at several locations along this portion of the top of slope.

- Perched fill located along the top of slope east of the landslide headscarp, area shown on Figure 2, should be pulled back to minimize the likelihood of a fill slope failure. Detailed recommendations for pull back of material should be provided by a qualified geotechnical engineer. Work should be conducted under the full time review of a geotechnical engineer;

- A geotechnical engineer should review the old road/trail, shown on Figure 2, that is located below the top of slope beyond the north side of the quarry and determine if any deactivation or drainage improvements are required; and

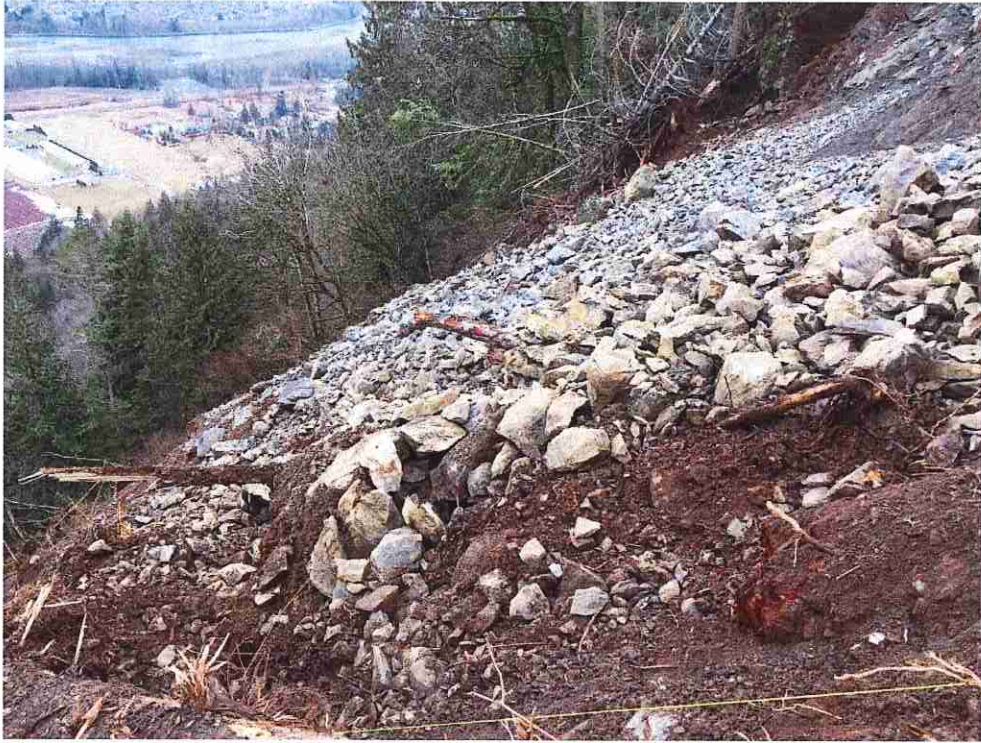
Photograph 1. – Loose cobbles and boulders immediately below initiation zone.

- Western Explosives Ltd. should safely pulled back any residual loose blast rock or fractured bedrock within and immediately below the landslide headscarp. Loose rock immediately below the scarp could be a rock fall hazard downslope;

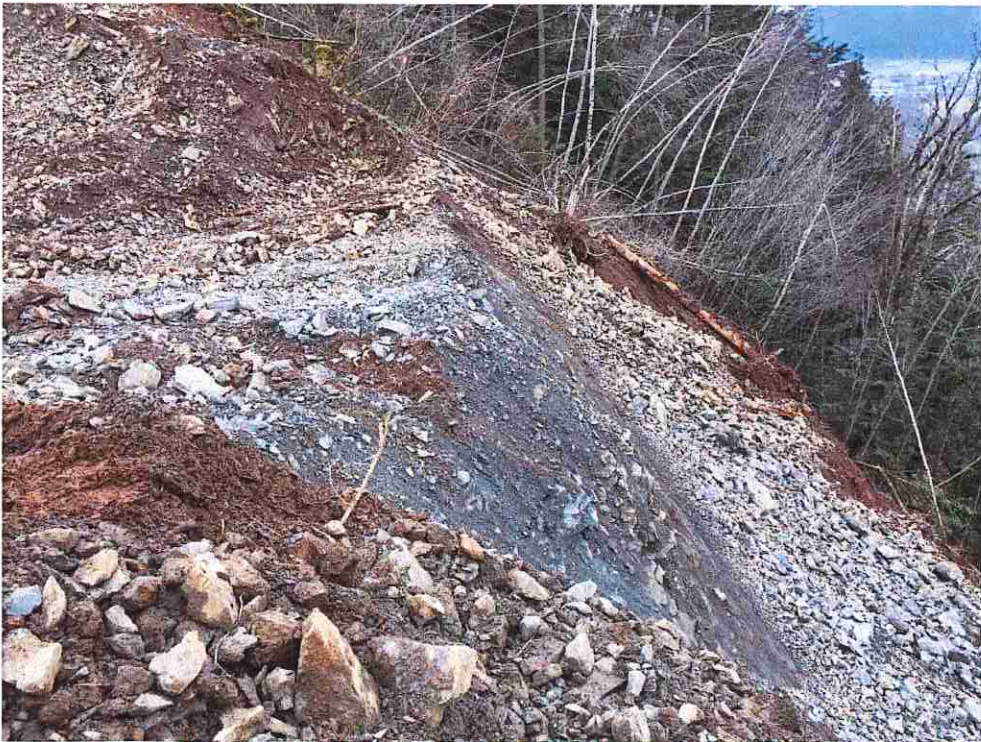
Photograph 2. – Initiation Zone viewed toward the west.

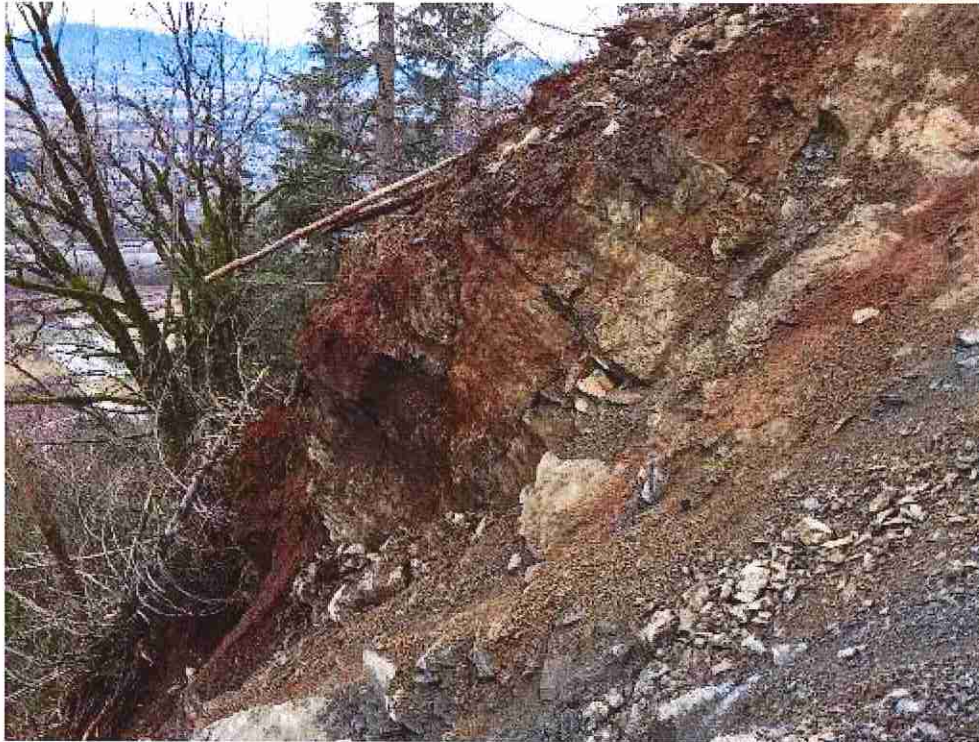
- An old road/trail is located below the top of slope and may have failed due to perched fill on this trail;
- Based on our observations, a bedrock failure likely occurred within the initiation zone. The bedrock was moderately fractured and appears to have failed along some of these fractures and joints;

Photograph 3. – Initiation zone viewed to the east. Note the fractured bedrock.

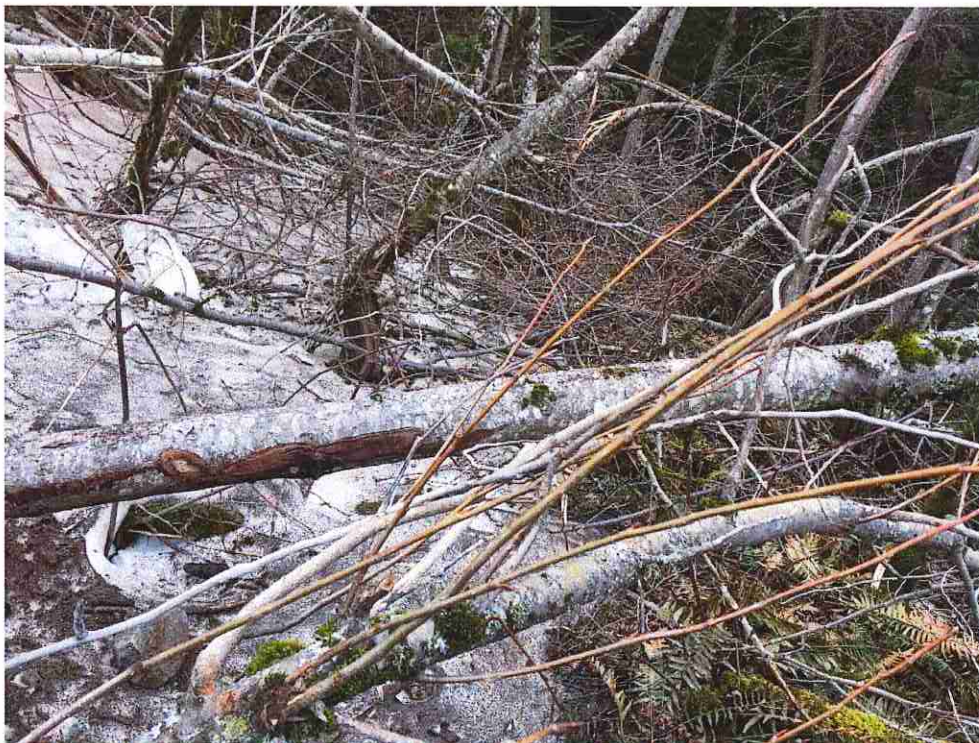
A narrow old road/trail, up to about 3 m wide, was observed at WP. 15 near the toe of the initiation zone (Photograph 4). No fill slope failures were observed along the old road/trail immediately west of the headscarp. The east portion of the old road could not be accessed.

Photograph 4. – A 2 to 3 m wide old road/trail located immediately below the initiation zone. Viewed to the west of the landslide.

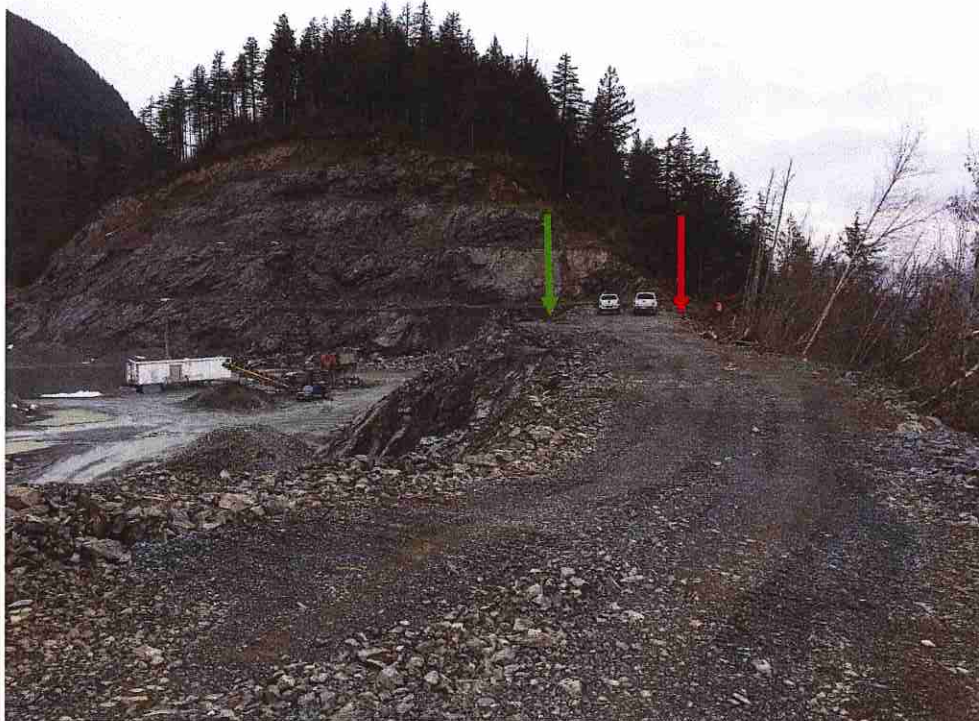
Overloading the top of slope with blast rock material while blasting was taking place about 10 m to the south were likely the main contributing factors.

Photograph 5. – Approximate blasting area location shown with a green arrow and the landslide initiation zone shown with a red arrow.

- Blasting should not be conducted adjacent to the top of slope until the perched fill slope and residual loose blast rock has been removed. The geotechnical engineer should also provide recommendations for stockpile setback from the top of slope. The actual blasting setback distance should be determined by a geotechnical engineer.

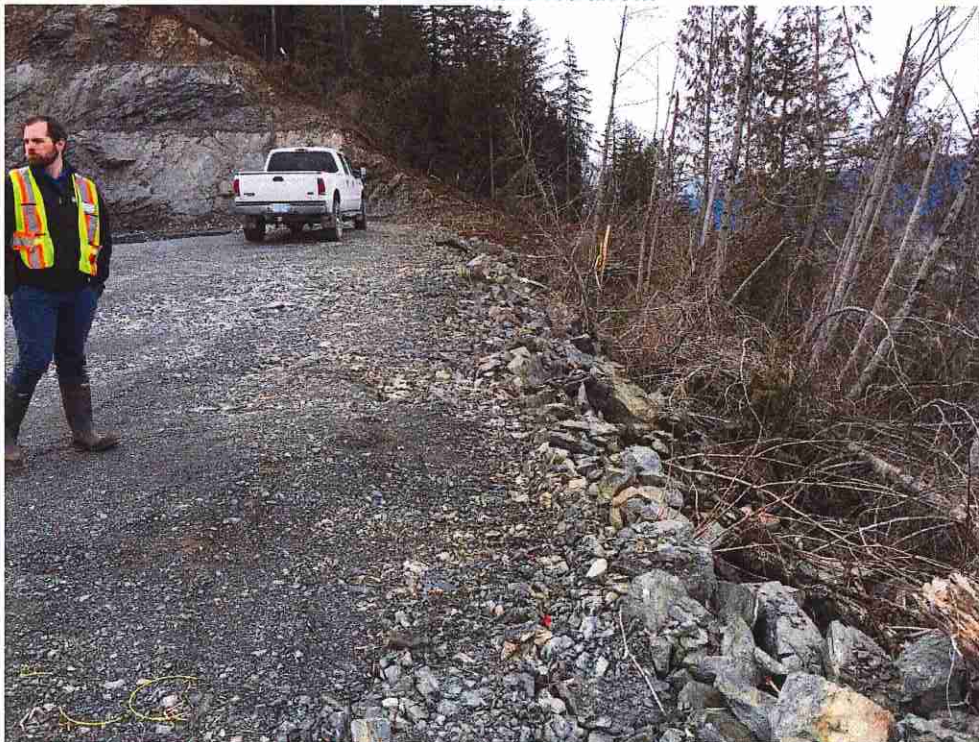
Photograph 6. – Perched fill along top of north slope of quarry viewed to the west.

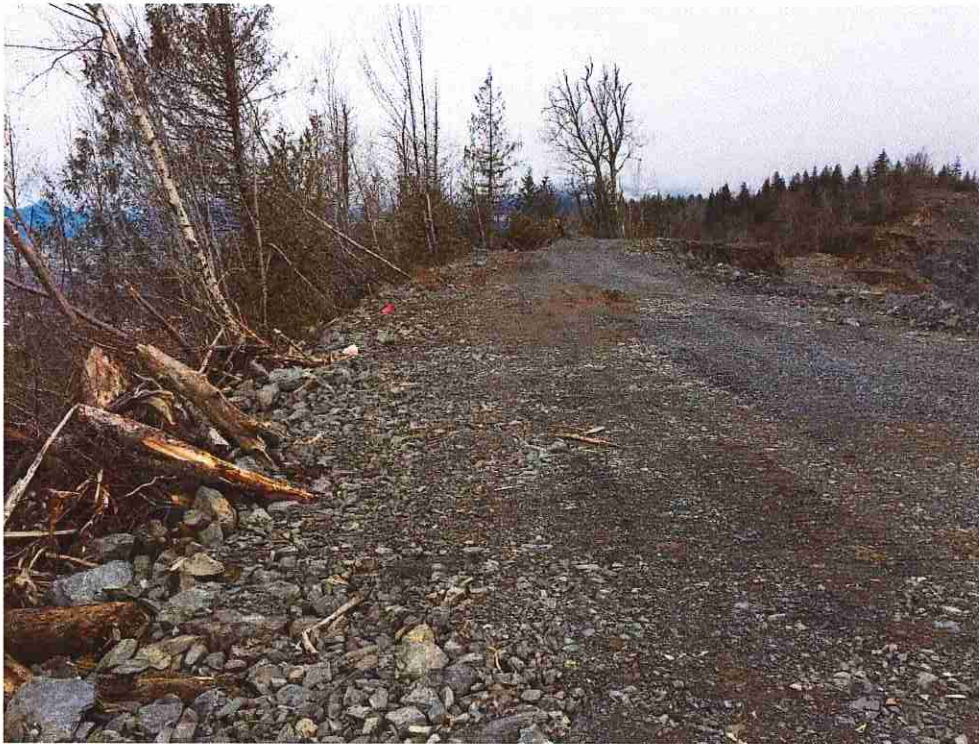
Photograph 7. – Perched fill along top of north slope of quarry viewed toward the east.

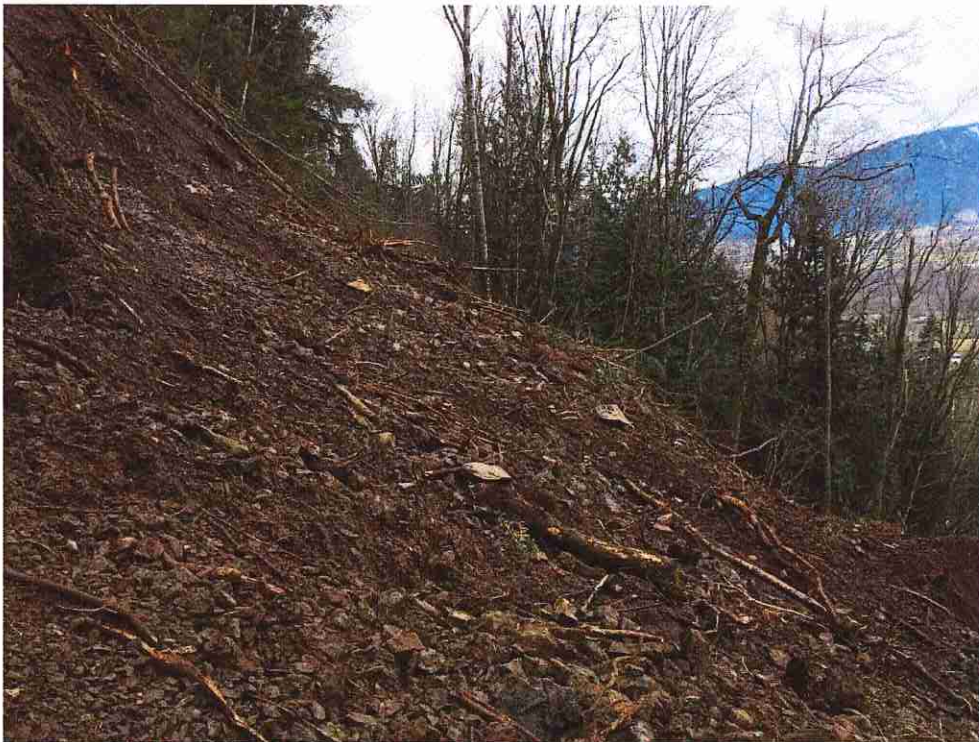
Immediately below the initiation zone, the slope failure formed a debris avalanche that was up to about 40 m wide. The slopes range between about 35 and 60 degrees for about 80 m to the Vedder FSR. The Vedder FSR at WP. 8 was destroyed within the debris avalanche path (Photograph 8). The FSR was noted at the east and west ends of the debris avalanche path. The FSR was up to about 2 m wide and overgrown with alder that was less than 10 years old. No slope instability was observed along the FSR immediately east and west of the debris avalanche path.

Photograph 8. – Location of Vedder FSR impacted by debris avalanche.

We understand that the Vedder FSR was permanently deactivated in 2009. However, if the City or Chilliwack Forest District proposes to reconstruct the road for a future trail or FSR, they should engage a geotechnical engineer to provide recommendations for reconstruction of the trail and conduct a hazard assessment to determine if there are any upslope hazards that could put road or trail users at risk.

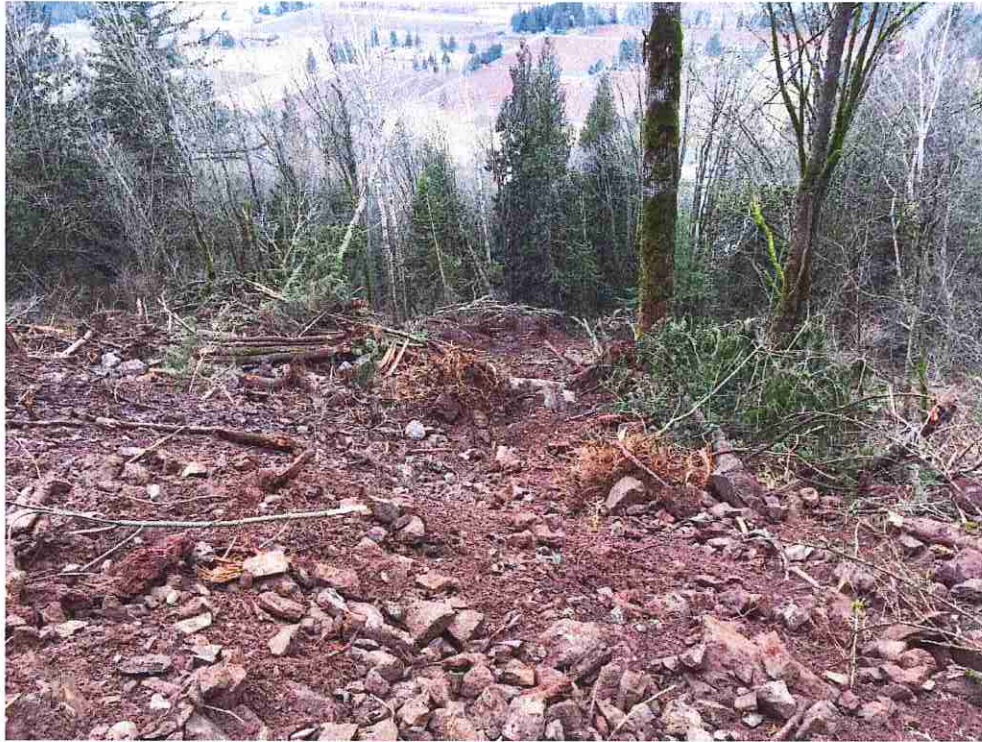
Photograph 9. – Loose cobbles and boulders downslope of Vedder FSR.

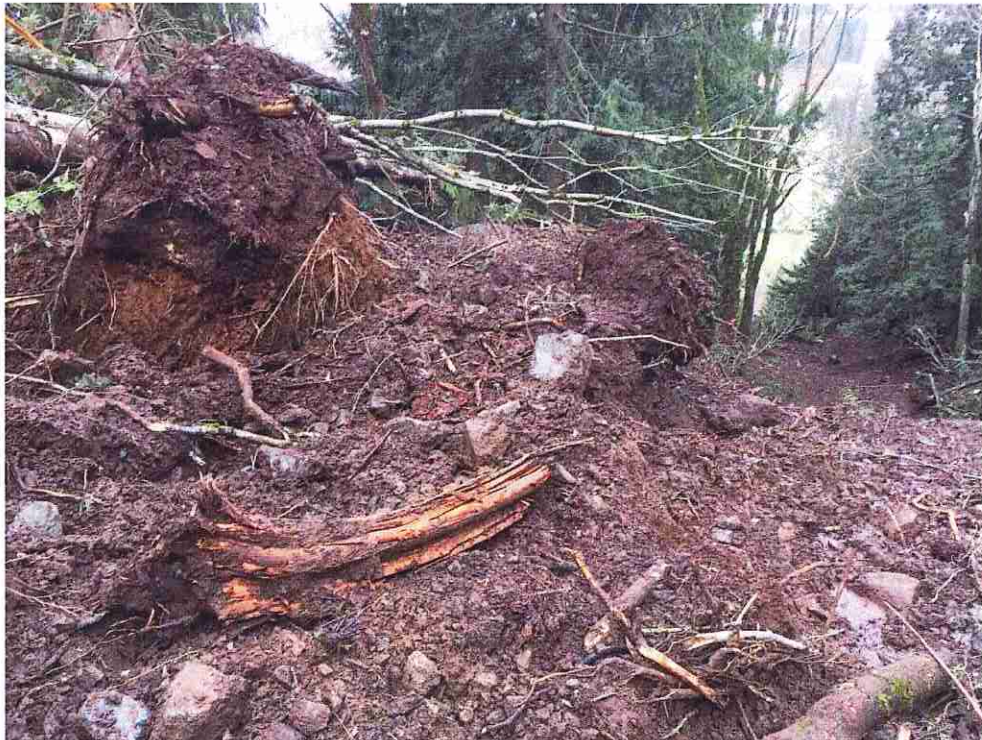
A large debris lobe up to about 1.5 m high, 12 m wide and 8 m long was observed near WP. 7 (Photograph 10). A majority of the debris was deposited on the 20 degree slope.

Photograph 10. – Debris lobe on 20 degree slope in partial deposition zone.

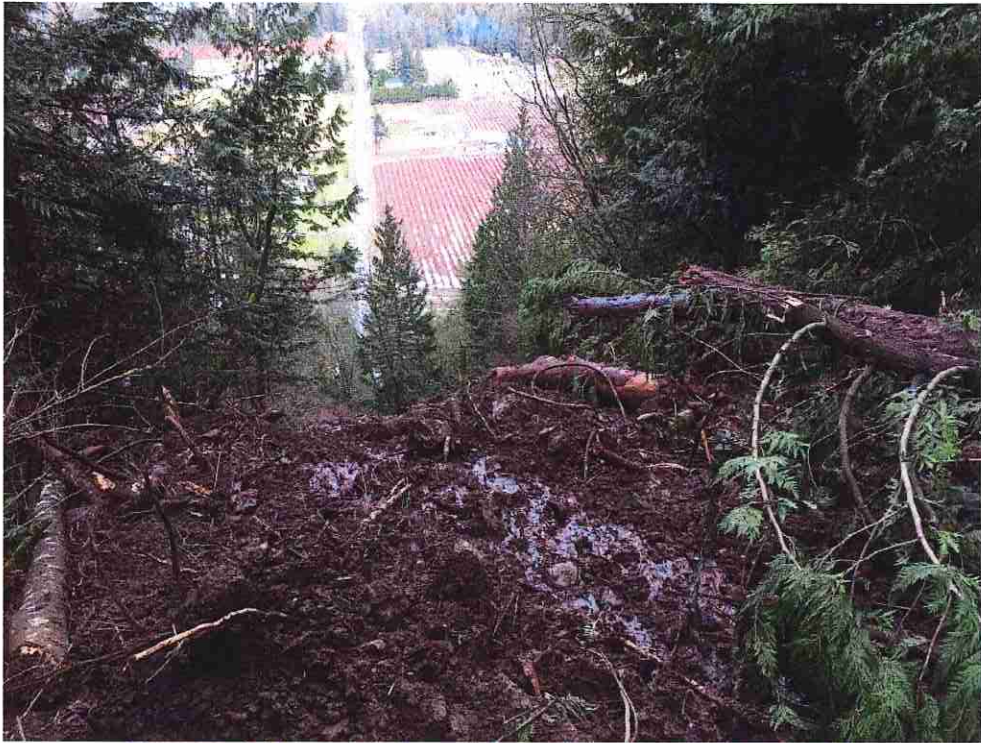
From WP. 6 to WP. 12 the slopes steepen and average about 35 degrees for 200 m. Downslope of WP. 6, the landslide becomes channelized into a debris flow within a shallow swale up to 1 to 2 m deep (Photograph 11). Debris levees up to about 1 m high were observed within this section. The debris flow path ranged between 5 and 15 m wide and surface water flow was also observed within this portion of the path. The path was scoured down to bedrock in portions of the debris flow.

Photograph 11. – Debris flow confined in shallow swale near WP. 5.

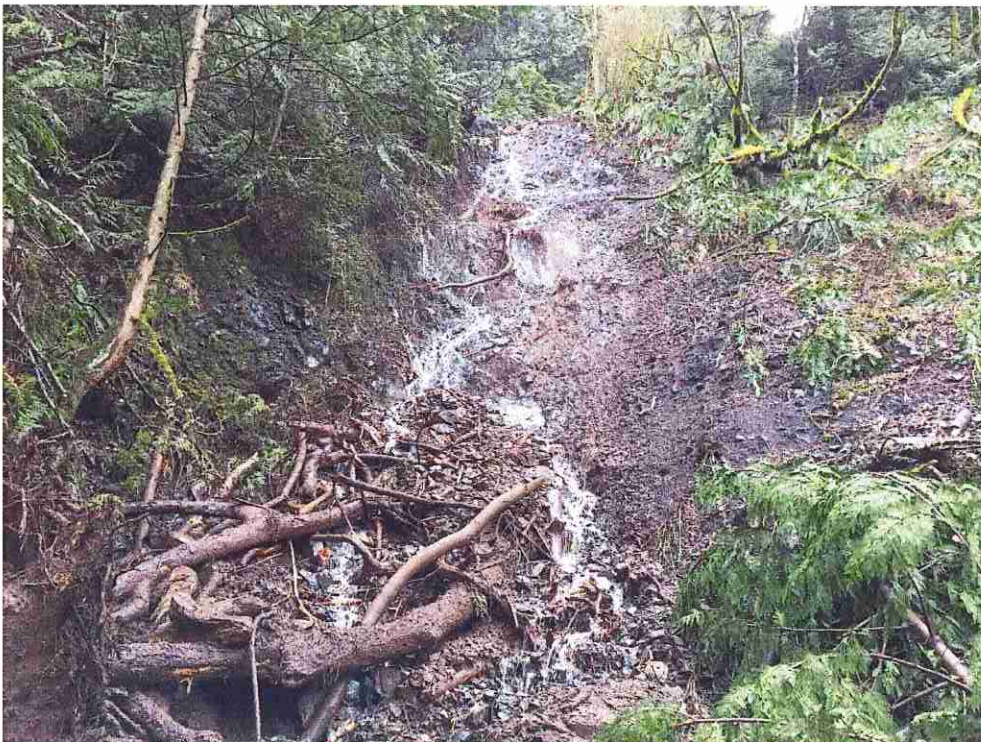
Photograph 12. – Debris lobe at termination of debris flow in gully.

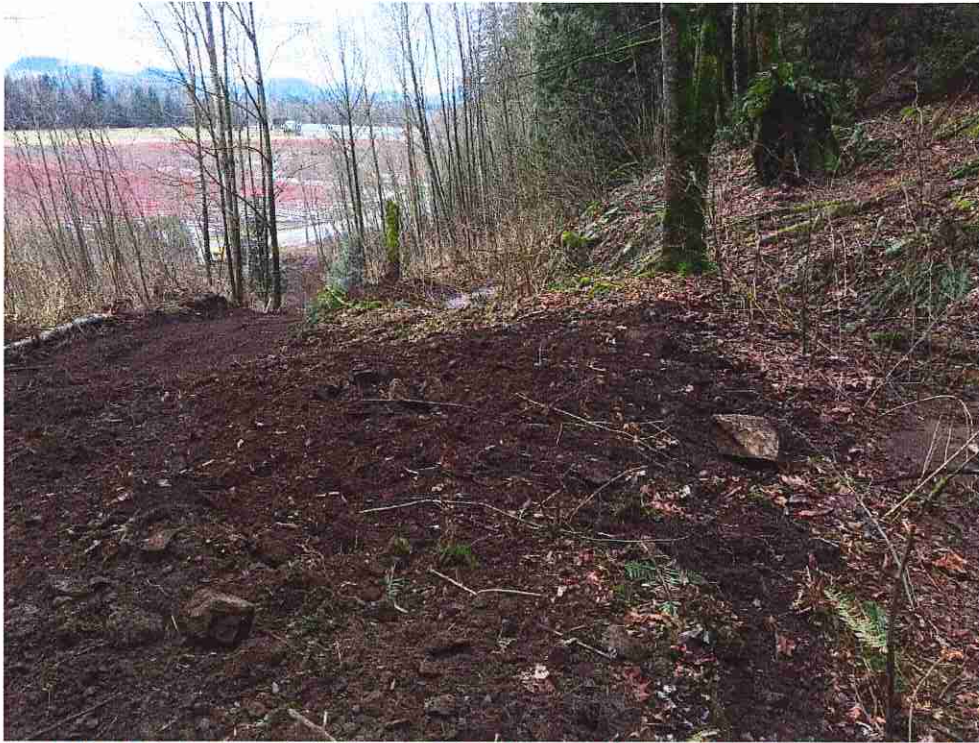
The slopes below the termination zone ranged between about 15 and 20 degrees for about 35 m to WP. 13. An existing berm about 1 m high and 1.5 m wide was observed at WP. 13 and extended from the west gully sidewall to the east side (Photograph 13). A berm and ditch extend beyond the east side of the mouth of the gully and diverts stream flow further east into the property located at 44100 VMR and into the ditch along the south side of VMR.

Photograph 13. – Existing berm built prior to debris flow with diversion ditch conveying flows towards 44100 VMR to east.

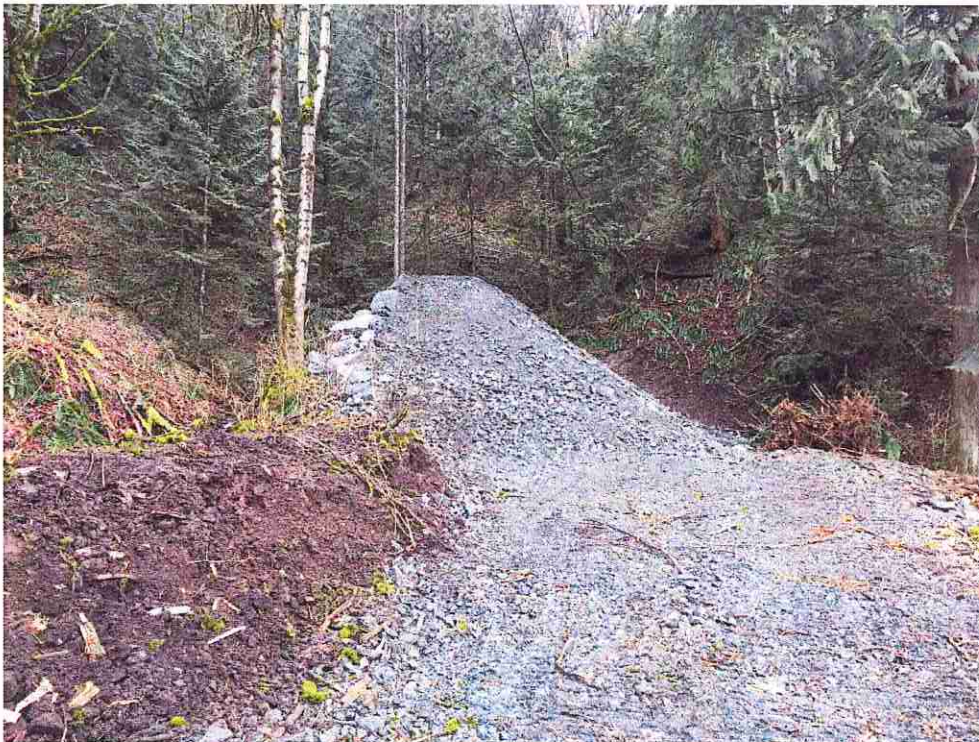
The new protective berm at the site was constructed over the existing berm to a height of about 3 m above the existing watercourse on the upstream side, about 1.5 m wide along the crest and approximately 15 m long (east of the west gully sidewall). The berm was constructed with 75 to 150 mm minus crushed rock and armoured with angular boulders up to about 1 m diameter on the upstream side (Photographs 14 and 15). The upstream side of the berm was sloped at approximately 1H:1V and the downstream side was sloped at about 1.2H:1V to 1.3H:1V. The berm is situated on a gently sloping bench with gradients ranging between 10 and 15 degrees for about 30 m downslope toward the residence. A ditch up to about 1 m deep and 1 m wide diverts flows from immediately upstream of the berm to the east and into 44100 VMR (Photograph 16). The ditch is not lined with rock and is comprised of native silty sand material.

Photograph 14. – Protective berm viewed to the west.

- The protective berm built upslope of the residence at 43980 VMR is considered suitable for use as a protective berm for mitigating future debris flows contained in the gully as well as residual material from the existing landslide. However debris may not be contained within the existing 1 m deep ditch east of the protection berm and could flow onto the access road and then onto VMR.

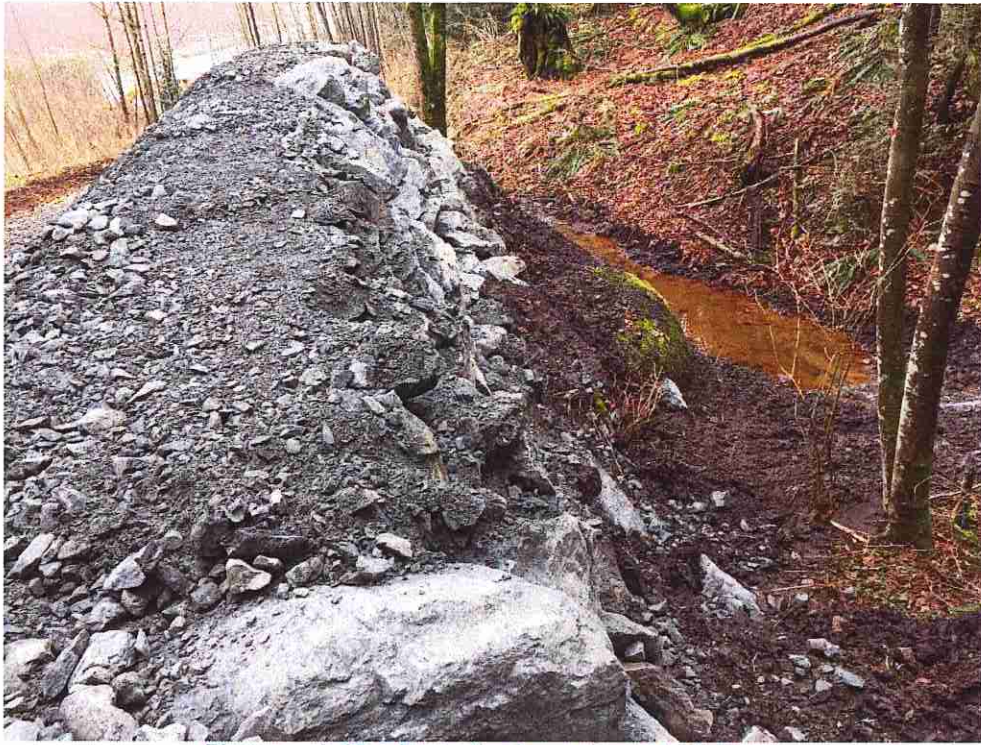
Photograph 15. – Protective berm viewed to the east.

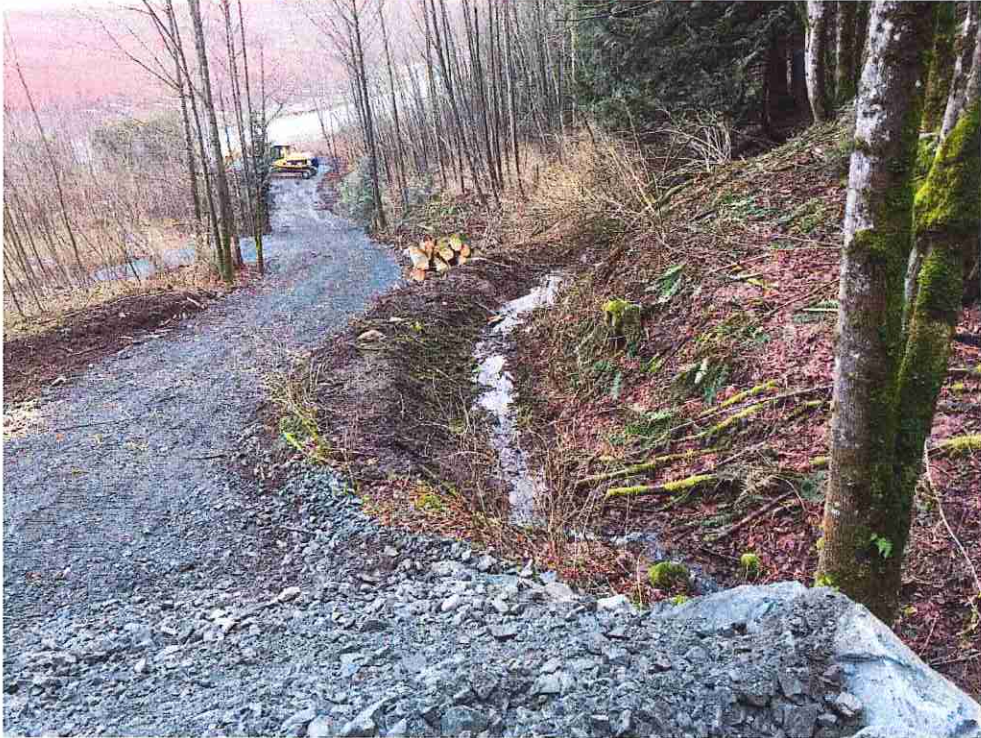
Photograph 16. – Ditch east of protective berm.

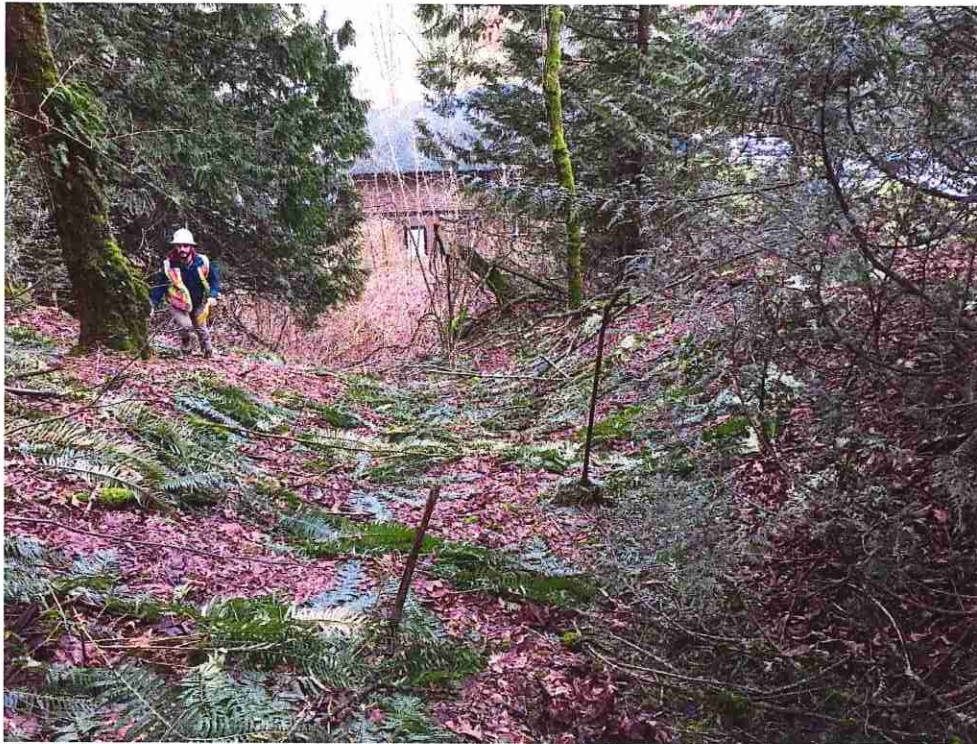
WSP also reviewed the slopes immediately upslope of the residence at 43980 VMR to the west of the gully. Two old debris lobes/levees from previous debris flows were observed at WP. 2 and WP. 3 and measured between 0.7 and 1.2 m high (Photographs 17 and 18). The debris lobe at WP. 2 was situated on gradients ranging between 15 and 22 degrees for about 50 m that extended to within about 15 m upslope of the residence. The debris lobes/levees were comprised of boulders and cobbles and based on the ages of the adjacent trees they were estimated to be about 30 to 40 years old.

Photograph 17. – Debris levee (on right side of photograph) about 30 m upslope of residence between WP. 2 and WP. 14.

- Several old debris flow levees and lobes were observed upslope of the residence at 43980 VMR on the west side of the gully and debris flows have occurred about 100 m to the east and west of the residence. In addition, the concrete foundation wall for the residence is only about 300 to 400 mm above surrounding grade and is setback about 3 m from a 2.5 to 3 m high 50 degree cut slope. It is unknown if a scour pad was constructed around the foundations of this residence as recommended by Geomedia. WSP recommends that a qualified geotechnical engineer with experience in terrain and slope assessment conduct a geotechnical hazard assessment to determine if any additional mitigative measures are required to reduce the risk of landslides impacting the house from potential landslides on the slopes west of the protective berm.

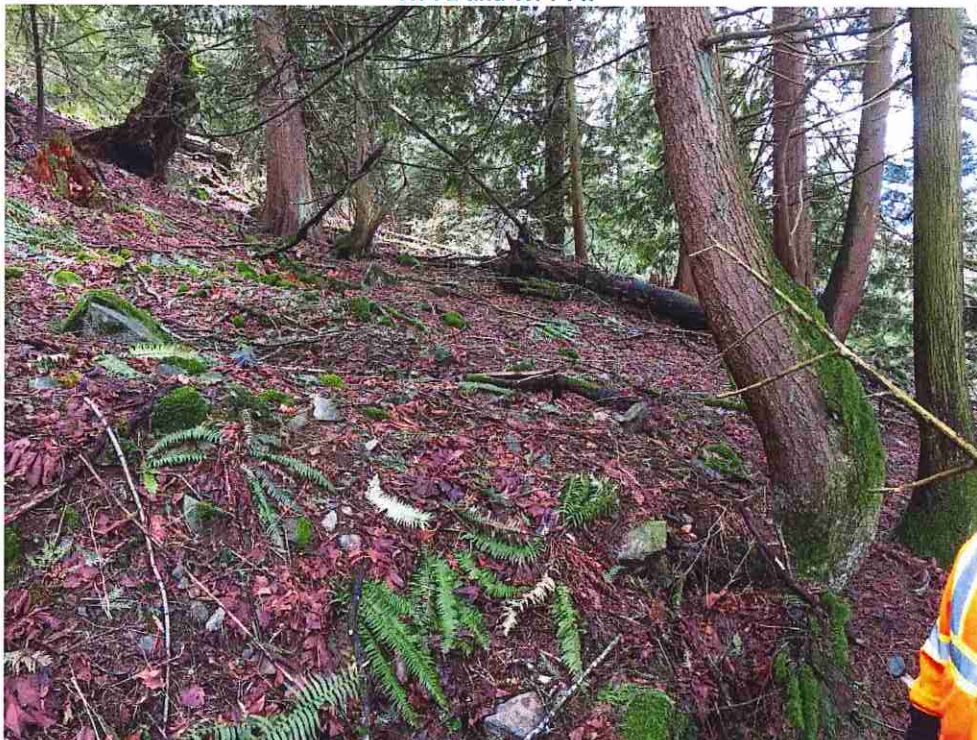
Photograph 18. – Debris lobe observed near WP. 3 with impacted tree on right side of photograph.

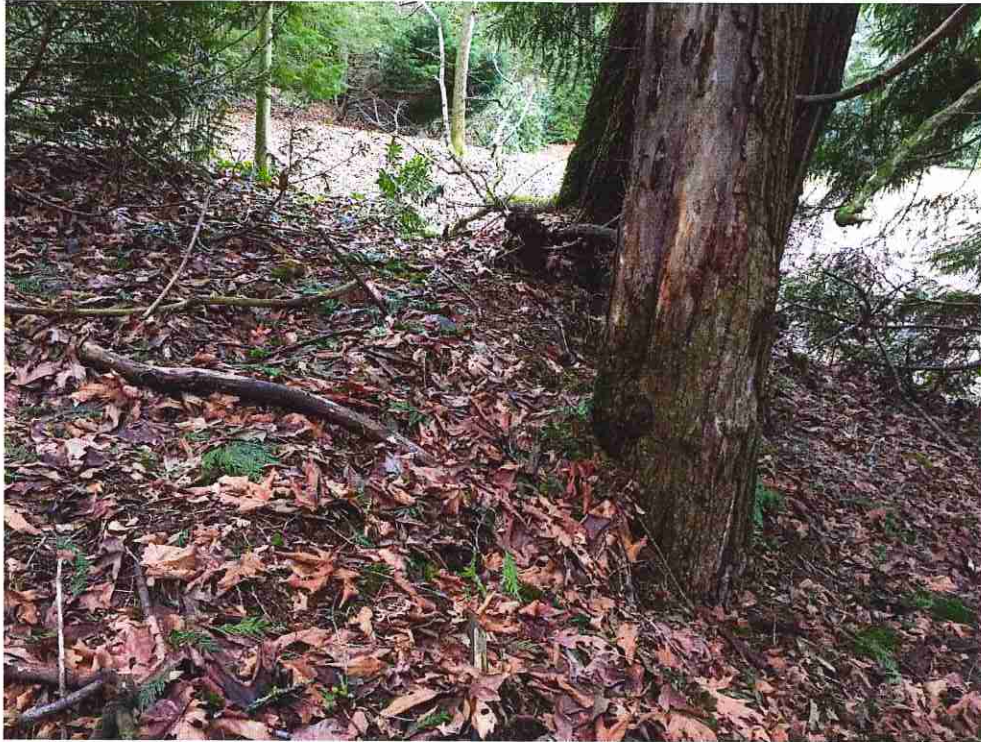
An old landslide, about 20 years old, was also observed about 100 m east of the residence. The initiation zone was about 15 m wide, 30 m long and 1 m high and initiated on a 40 degree slope. The runout extended about 130 m downslope to VMR. Debris levees and scarred trees were observed on the slopes below this landslide (Photograph 19).

Photograph 19. – Debris levee along east side of debris flow observed at 43920 VMR about 100 west of residence.

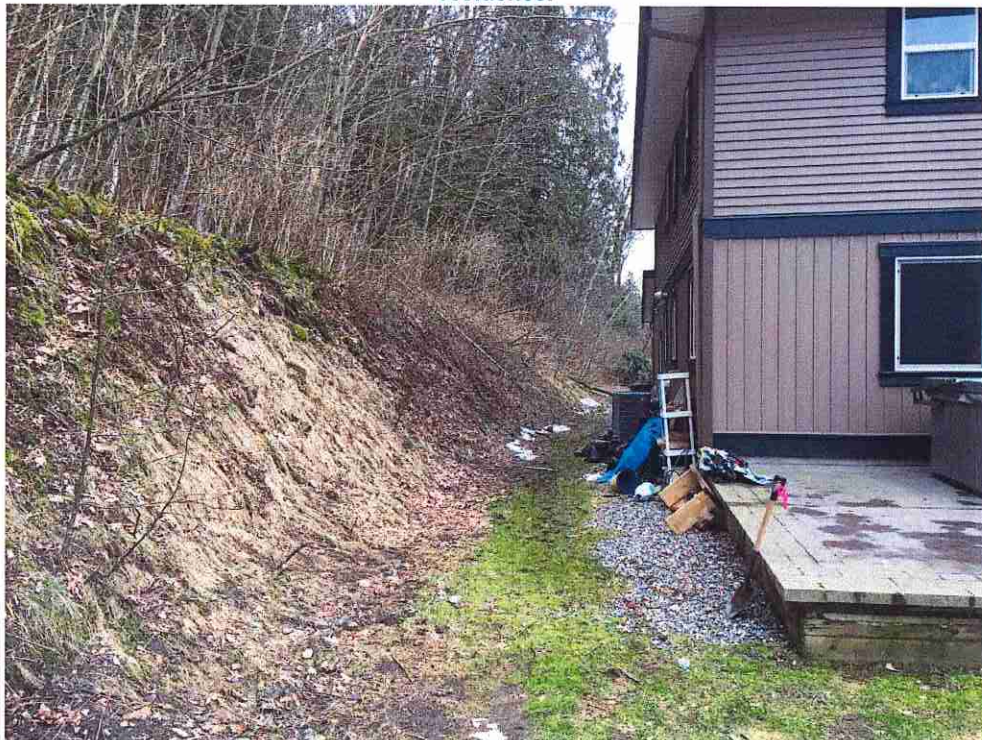
The south side of the residence was setback about 3 m from the toe of the cut slope (Photograph 20). The cut slope gradients immediately south of the residence ranged between about 45 and 50 degrees for up to 4 m. The cut slope is between approximately 2.5 and 3 m high and comprised of sand and angular gravel and some silt (alluvial deposits). The slopes above this cut slope ranged between 5 and 15 degrees for about 10 m then the gradients steepen to about 30 degrees for up to 50 m. The concrete foundation wall is approximately 300 to 400 mm above surrounding grades.

Photograph 20. – Approximate 3 m high slope immediately upslope of residence. Approximate 400 mm high concrete foundation wall along south side of residence.
